Autoguidance system operated at high speed causes almost no tomato damage

California Agriculture, 58(1)

Aziz Z. Abidine  
Brian C. Heidman  
Shrini K. Upadhyaya  
David J. Hills

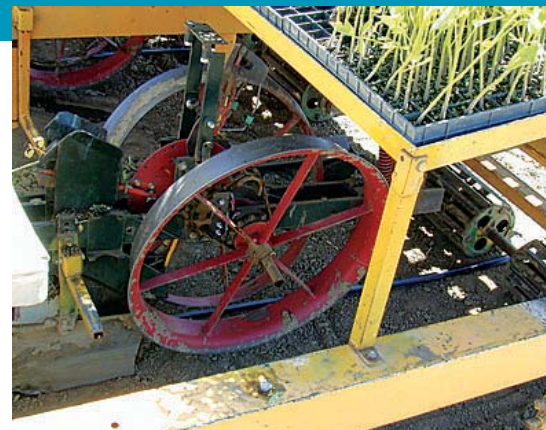
Ultraprecise global positioning systems (GPS) are now available that can guide tractors at high speeds in agricultural fields, running to within inches of plants with very little damage. Above, at UC Davis, tomato seedlings are transplanted using an autoguidance system. The GPS unit is on top of the tractor cab. Left, drip tape is installed at the same time.

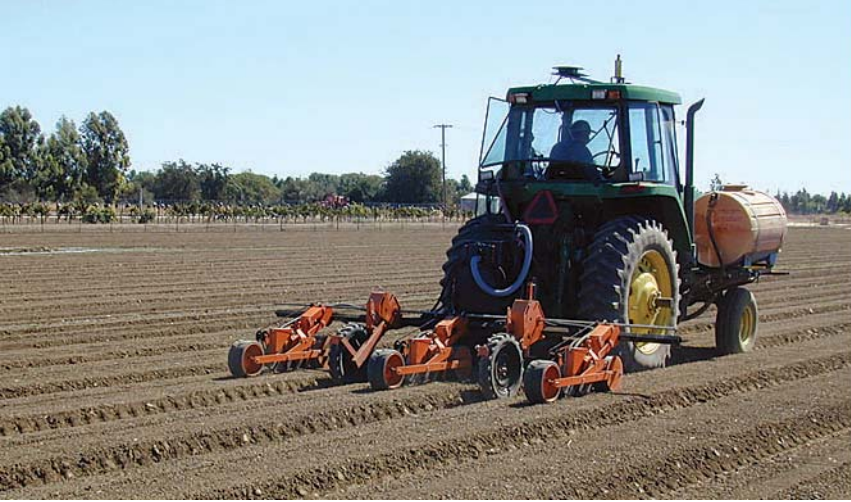
**Processing tomato seeds are planted using an autoguidance system. In two trials, total plant damage was 2% and zero when the autoguided cultivator was operated at 7 miles per hour and 2 inches from the plant line.**

age was less than 2% for the high-speed, low-spacing treatment (7 mph and 2-inch spacing from the plant line), which was more likely to cause plant damage (table 2). There was no damage at all due to any of the treatments in the second cultivation trial. These results indicate that the autoguidance system can steer a tractor very close to a plant line (within 2 inches) at relatively high speed (7 mph) without damaging plants.

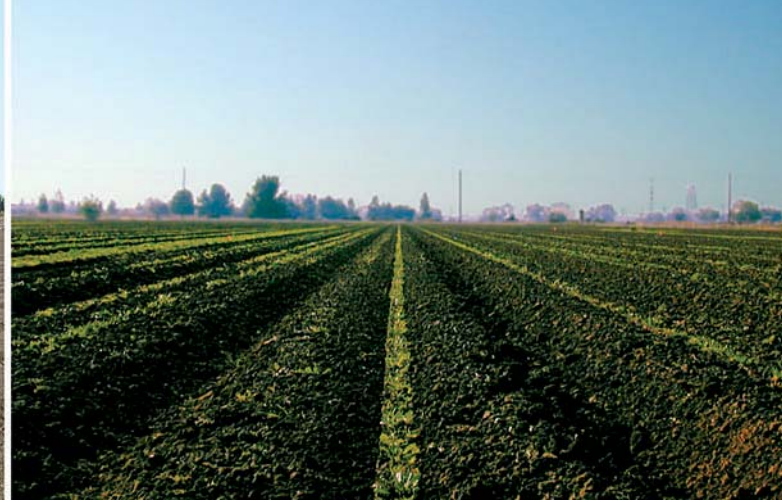
**The autoguidance tractor equipped with a cultivator leaves behind a narrow strip of untilled land along the plant line.**

However, we found sections of the field with a sufficient plant stand to continue the experiments. The field was cultivated 40 days after planting. Since the plants were quite small, about 6 inches high and 2.75 inches wide, a set of discs was used ahead of the cultivator knives. These discs left behind a narrow strip of untilled land along the plant line.

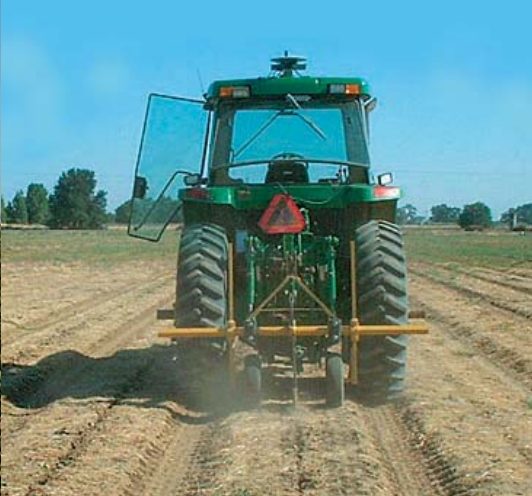
**Left**, a fertilizer shank is used in deep tillage operations to determine the ability of the autoguidance tractor and implement to stay clear of buried drip-tape. **Above**, on the light bar in the tractor cab, a green LED in the center indicates that the GPS unit is on track.

**Buried drip-tape.** The results of the tillage study using the fertilizer shank indicate that the autoguidance system can successfully navigate a tractor close to buried drip-tape without causing damage. The experiment resulted in drip-tape damage at only one spot at the beginning of one of the 48 rows. This damage occurred because the soil was quite hard and dry, and the shank followed a prevailing crack rather than cutting the hard soil; in turn, the shank bent and cut the tape. This damage could have been avoided if the shank was more rigid or the tillage operation was conducted at a more favorable soil-moisture content. In any case, overall damage to the drip tape was negligible.
